Vauxhall Cavalier/Opel

Installing the Vauxhall Cavalier 4 x 4 Transfer Box

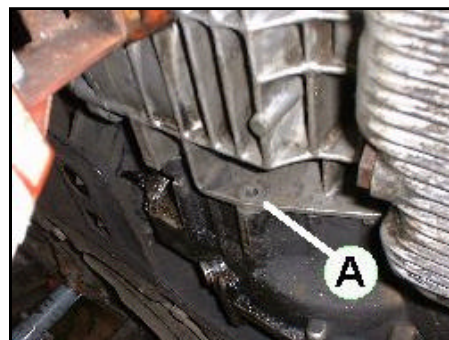
Figure 2

View from underneath the vehicle showing the txb supported by the jack.

A. Lowest bolt.

507. Jack the txb into position (Fig.2 & 3) so it can be slid into the gearbox opening. This is a difficult manoeuvre as the rear of the sump is not straight. Angle the txb up at the back so as to insert the propshaft end over the visible torsion bar. Take care not to damage the splined shafts.

509. As the txb slides into place, applying Loctite to the mounting bolts and loosely fix with the lowest bolt (Fig.2A) to keep it in position (Fig.4A & B). Once mated to the flange with the previously greased 'O' ring, the weight is not so critical.

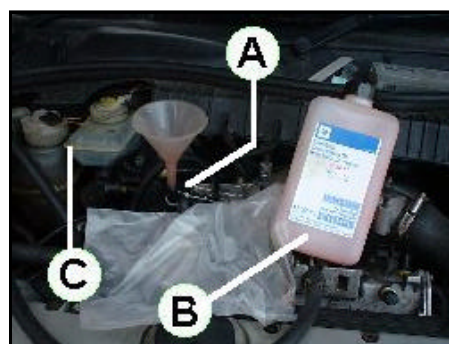
Figure 9

View of the offside rear bulkhead and the funnel set up, to fill the txb through the filler / breather pipe.

A. Funnel inserted into restrained filler pipe.

B. The 600ml bottle of GM synthetic oil.

C. The water header tank, behind which the filler pipe is stowed in normal service.

547. If not already, reconnect the filler/breather pipe to the top of the txb and insert the very small funnel into the end of the tube. The lower txb mounting bolt adjacent to the txb temp sensor should be removed and a drip tray placed into position. Fill the txb (approx. 600 ml) until fluid has ceased to flow from the lower mounting bolt hole. Locktite and replace the mounting bolt and tighten. Ensure the filler tube is routed away from moving/hot parts. The top of the tube should be turned over, without kinking, and lodged beside the water header tank. It is important the tube is without kinks and can properly act as a breather (Fig.9C)
